CUNNANE STRATTON REYNOLDS

TREE SURVEY

Fortunestown Site, Co Dublin.

March 2017

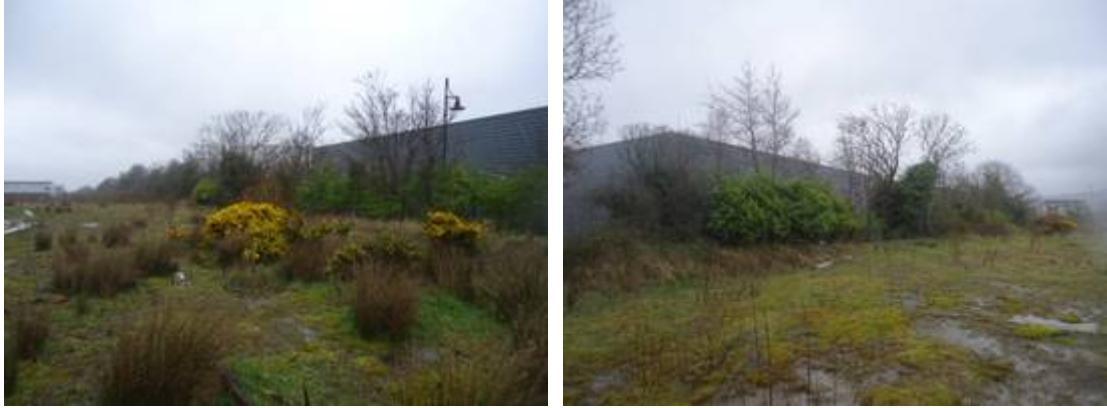
Tree Group 1 is a mixed group of deciduous and pine trees of moderate to low quality, the majority of which are relatively young with a small number of older trees interspersed, (some of which are located on the adjoining land on the far side of a deep drainage ditch - meaning their roots are unlikely to extend into the site).

Tree Group 1 (eastern boundary)

The proposed development appears to be compatible with the retention of all trees located along the eastern site boundary, (T62-75 / Tree Group 1), their retention being dependent on a relatively modest set back distance to ensure their root protection zone is not compromised. Current proposals for this side of the site include public open space, playing fields and school development all of which facilitate adequate protection of the trees roots.

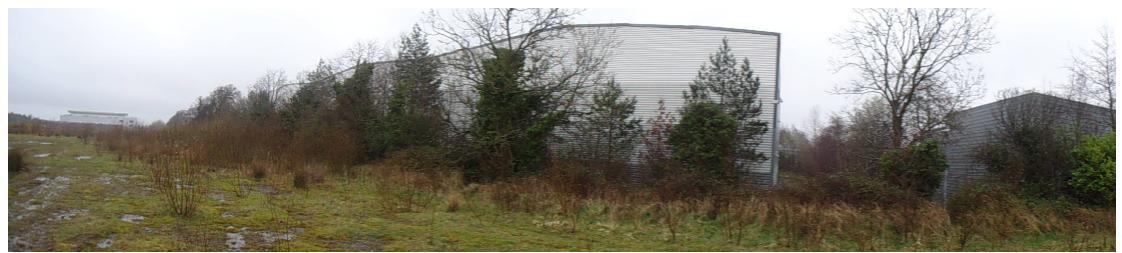
Tree Group 1 (eastern boundary)

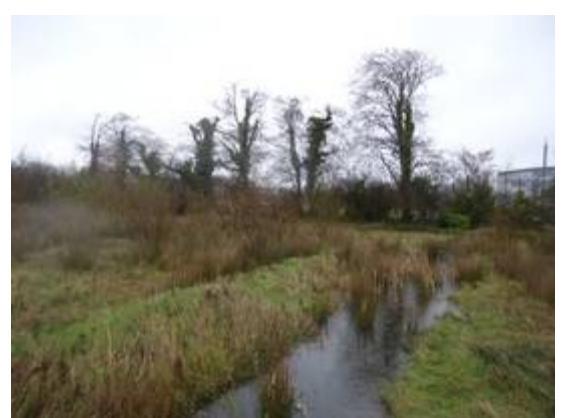
Tree Group 1 (T69-T75)

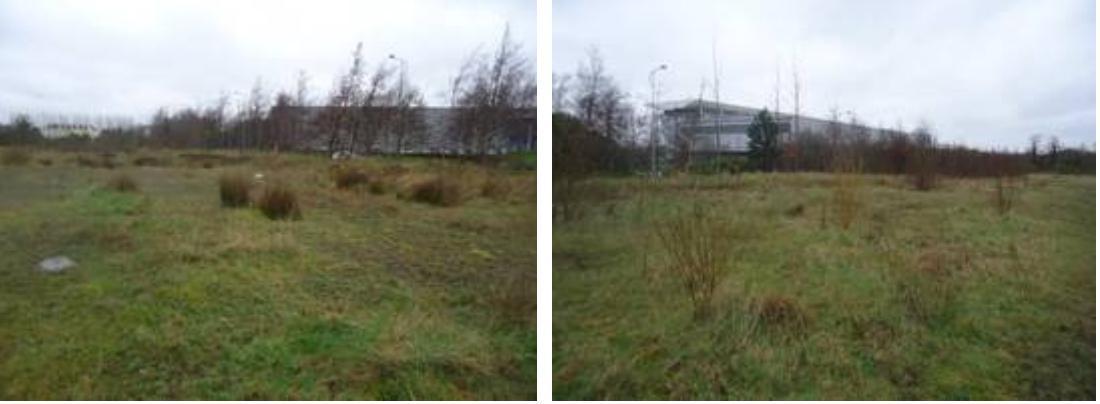
Tree Groups 2 & 4 are formed of regenerative wetland scrub and tree largely still at a sapling growth stage. These are located primarily along the northern and western boundaries.

Tree Group 2 (Northern boundary)

3.3 Direct loss of trees is limited to the removal of Tree Groups 3 (partial) and 4, along with other areas of early stage regenerative tree and scrub growth from within the site, which is not considered to be of arboricultural significance - particularly in the context of the proposed level of tree planting within the scheme as set out in the Landscape Masterplan.

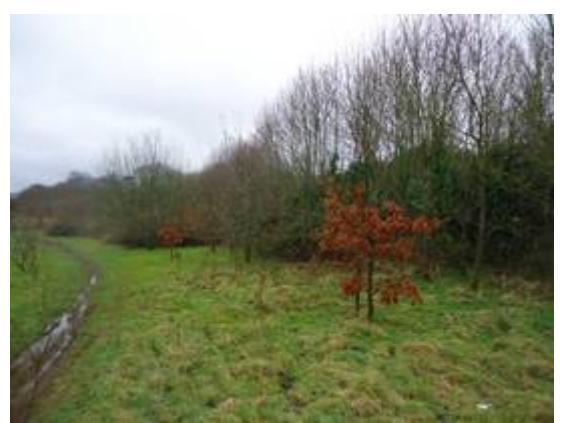
Tree Group 3 is formed of a belt of young Ash tree planting lines most of the western boundary approximately 5-10m wide.

Tree Group 3 & 4 (Western boundary)

Some of the existing young trees located along the western site boundary, (T76 / Tree Group 3), are likely to be compatible with retention where desirable within the proposed linear open space. Removals will also be made from this relatively juvenile tree belt, however these are considered to be without significant arboricultural issue given their immaturity. (This tree belt would benefit from thinning to create space for the proper development of the remaining trees).

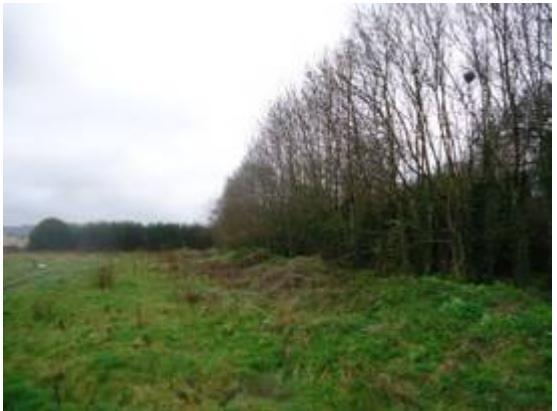
Tree Group 3 (Western boundary)

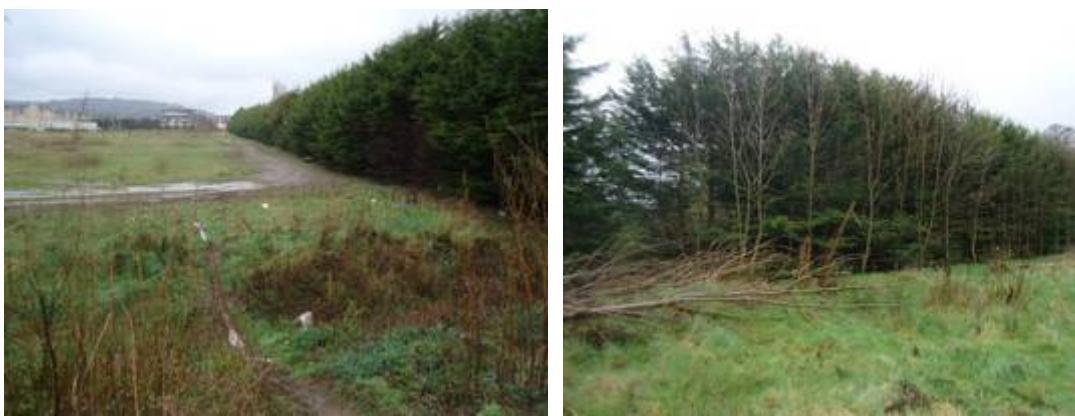
Tree Group 5

The southwest corner of the site is bounded by a continues row of mature evergreen cypress trees, (Tree Group 5).

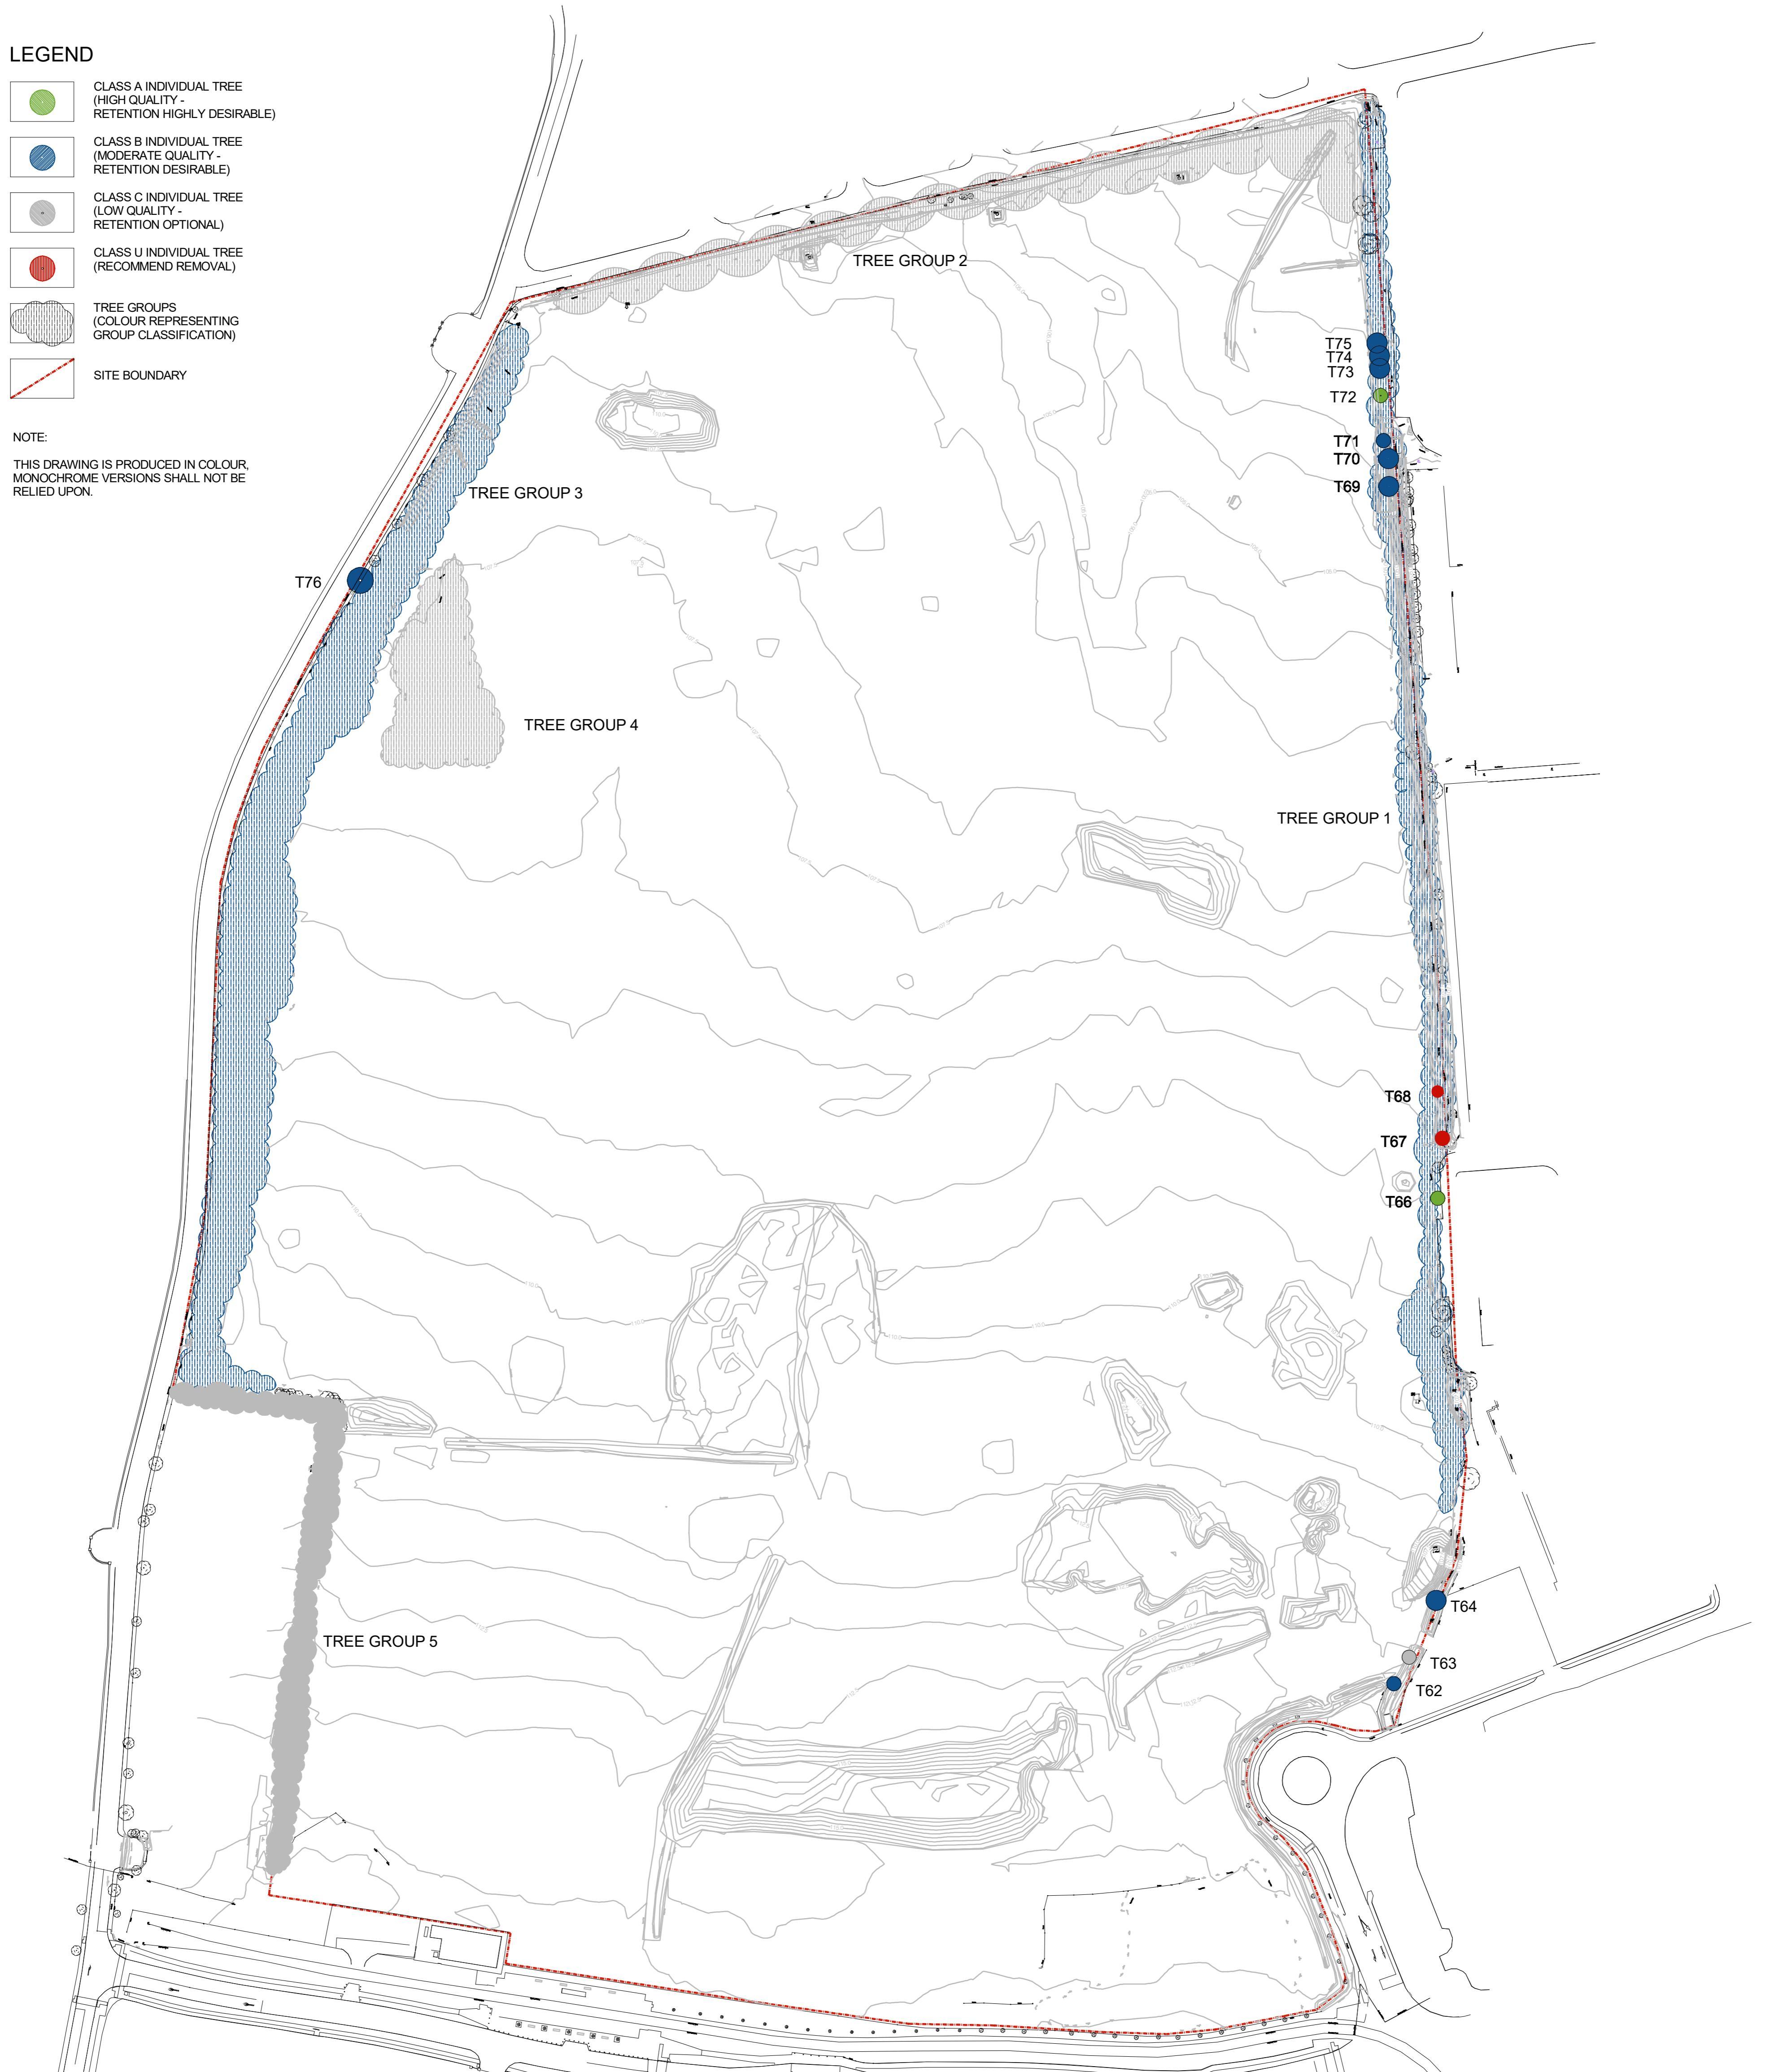
PROJECT:	DATE:	MARCH 2017
COOLDOWNS COMMON, CITY WEST MASTERPLAN	SCALE:	1:1250 @ A1
DRAWING:	DRAWN: CHECKED:	INIT KM
TREE SURVEY CLASSIFICATION	DRAWING NO:	15422-T-101

A total of fifteen individual trees and five 'Tree Groups' were inspected. Their location, size and quality category may be reviewed with reference to the accompanying Tree Classification Dwg No 15422/T/101 and the tree survey (Appendix 1).

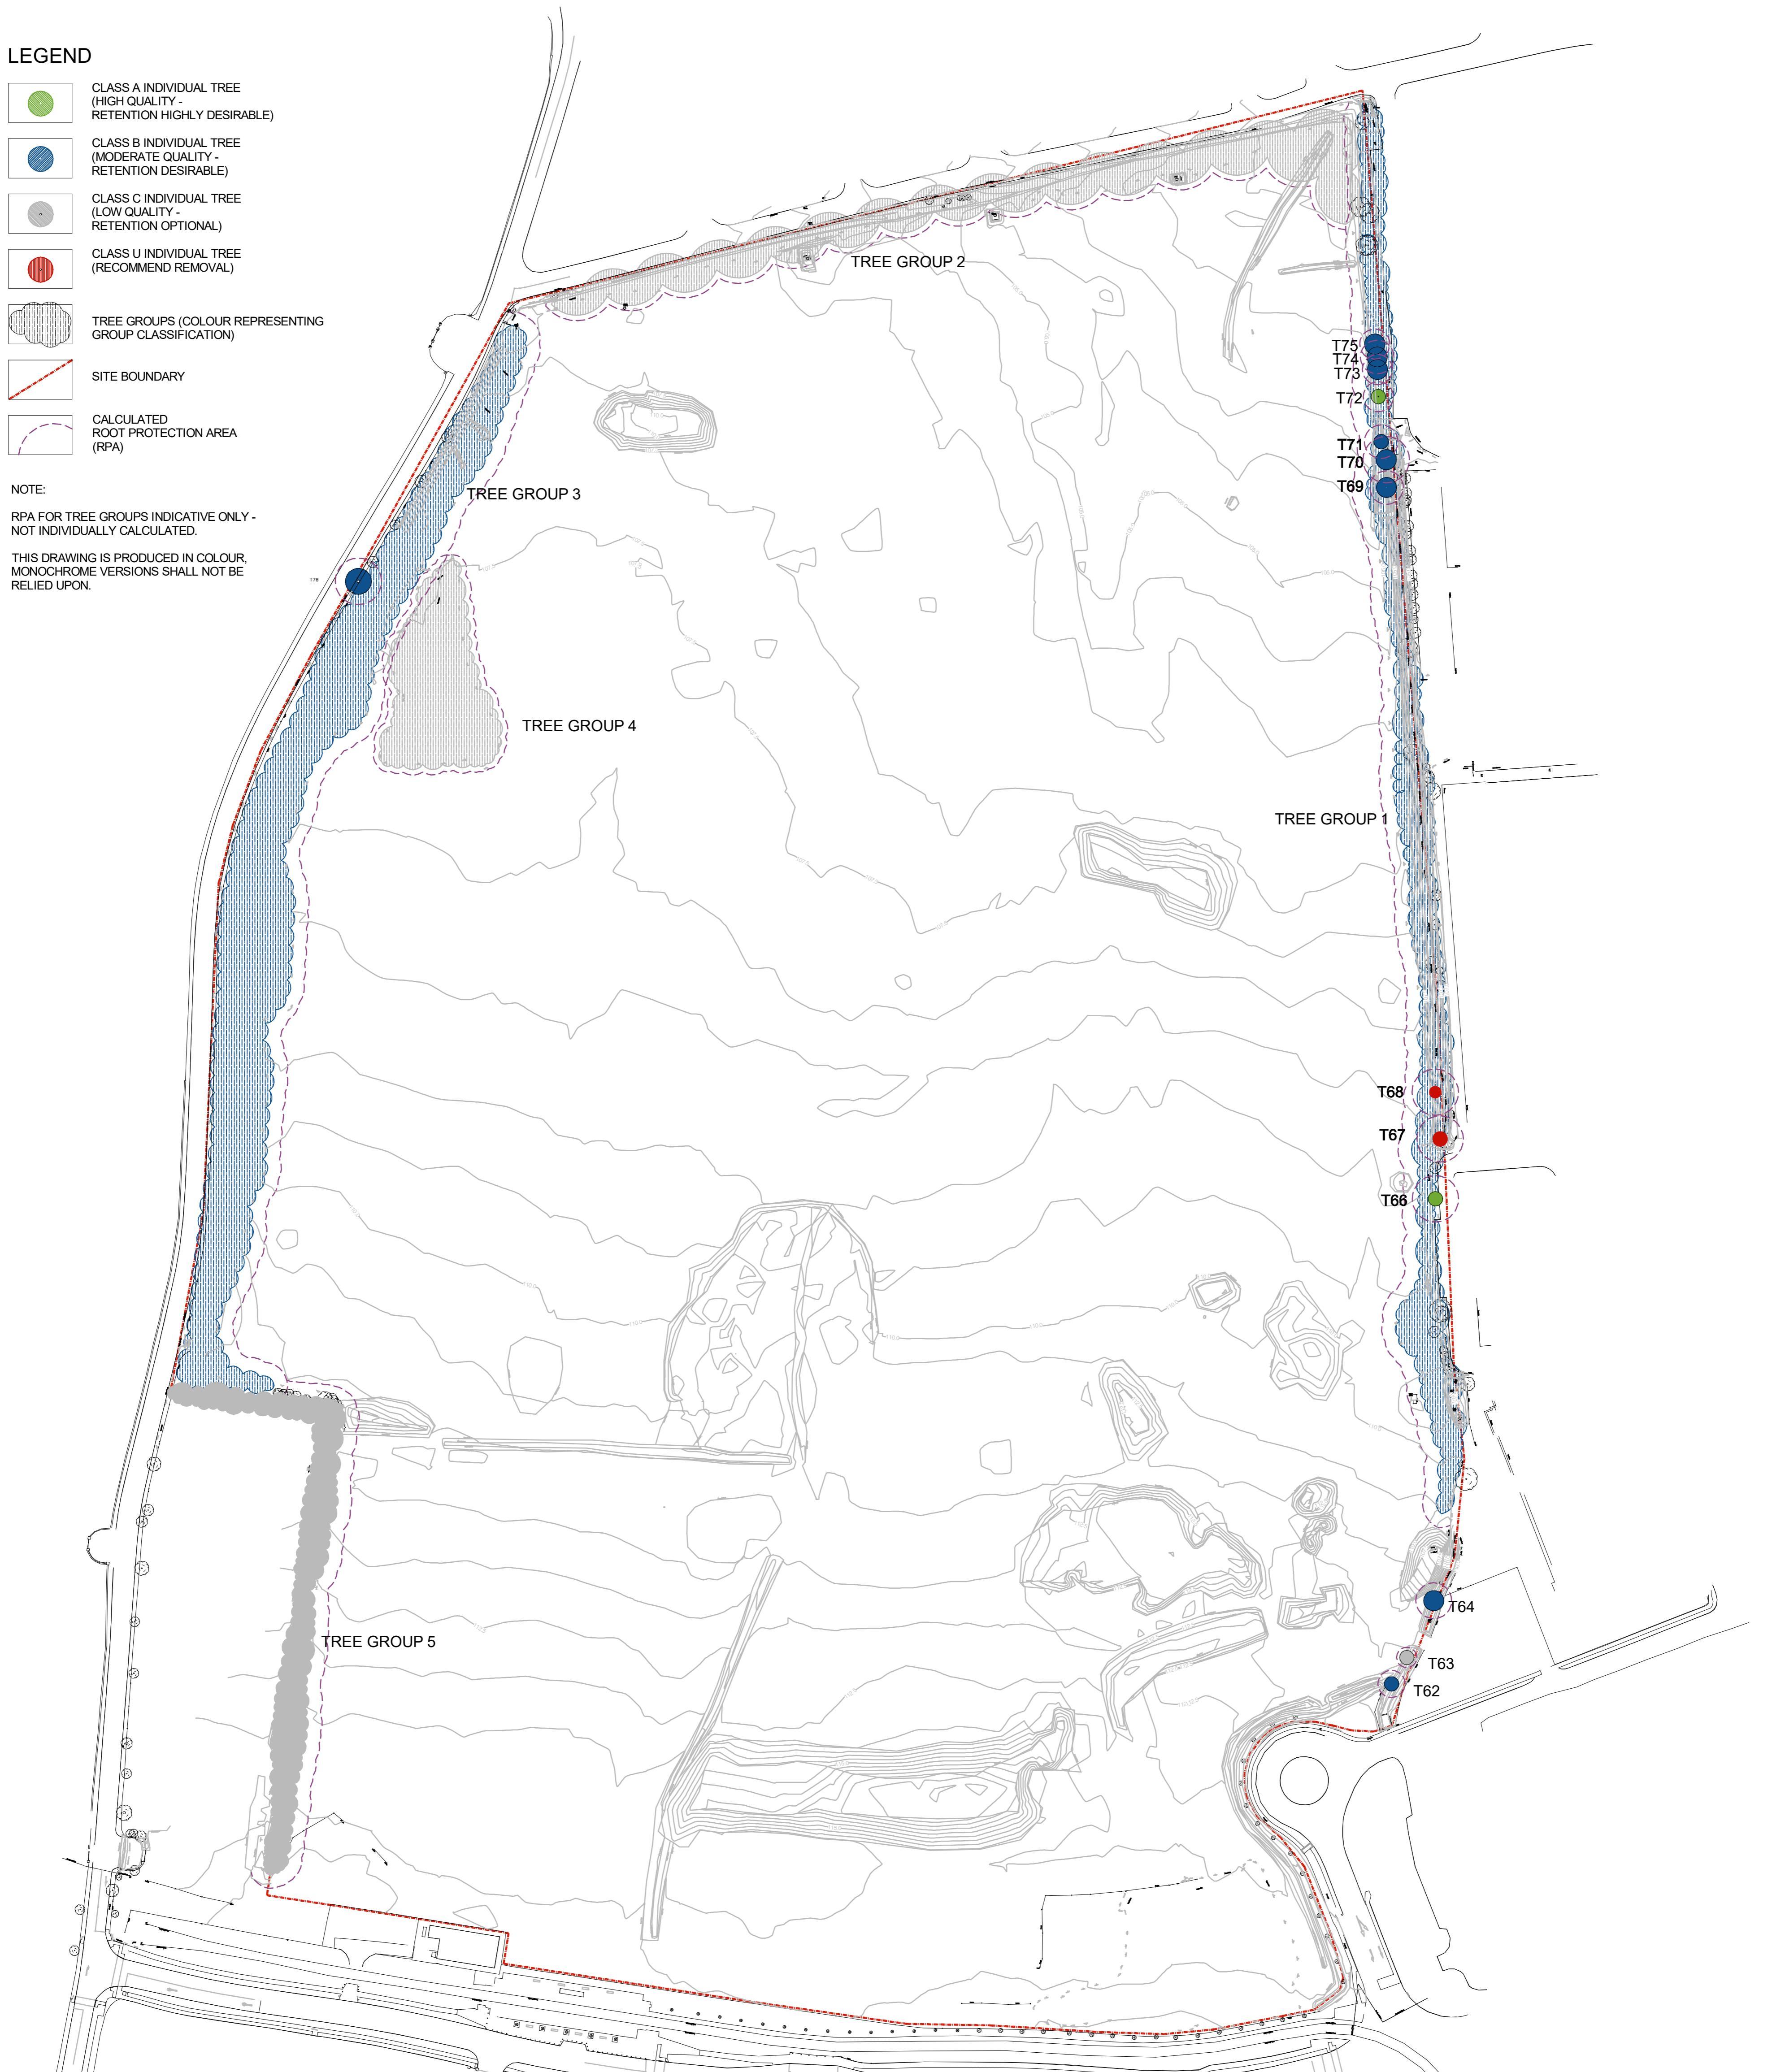
PROJECT:	DATE:	MARCH 2017
COOLDOWNS COMMON, CITY WEST MASTERPLAN	SCALE:	1:1250 @ A1
DRAWING:	DRAWN: CHECKED:	INIT KM
TREE CONSTRAINTS	DRAWING NO:	15422-T-102

3.4 Cognisance must also be given to indirect impacts - in particular care must be taken to ensure the proposed development and ancillary works do not represent an unacceptable conflict with the calculated 'Root Protection Area' of the existing trees - as illustrated in Tree Constraints Dwg No 15422/T/101.

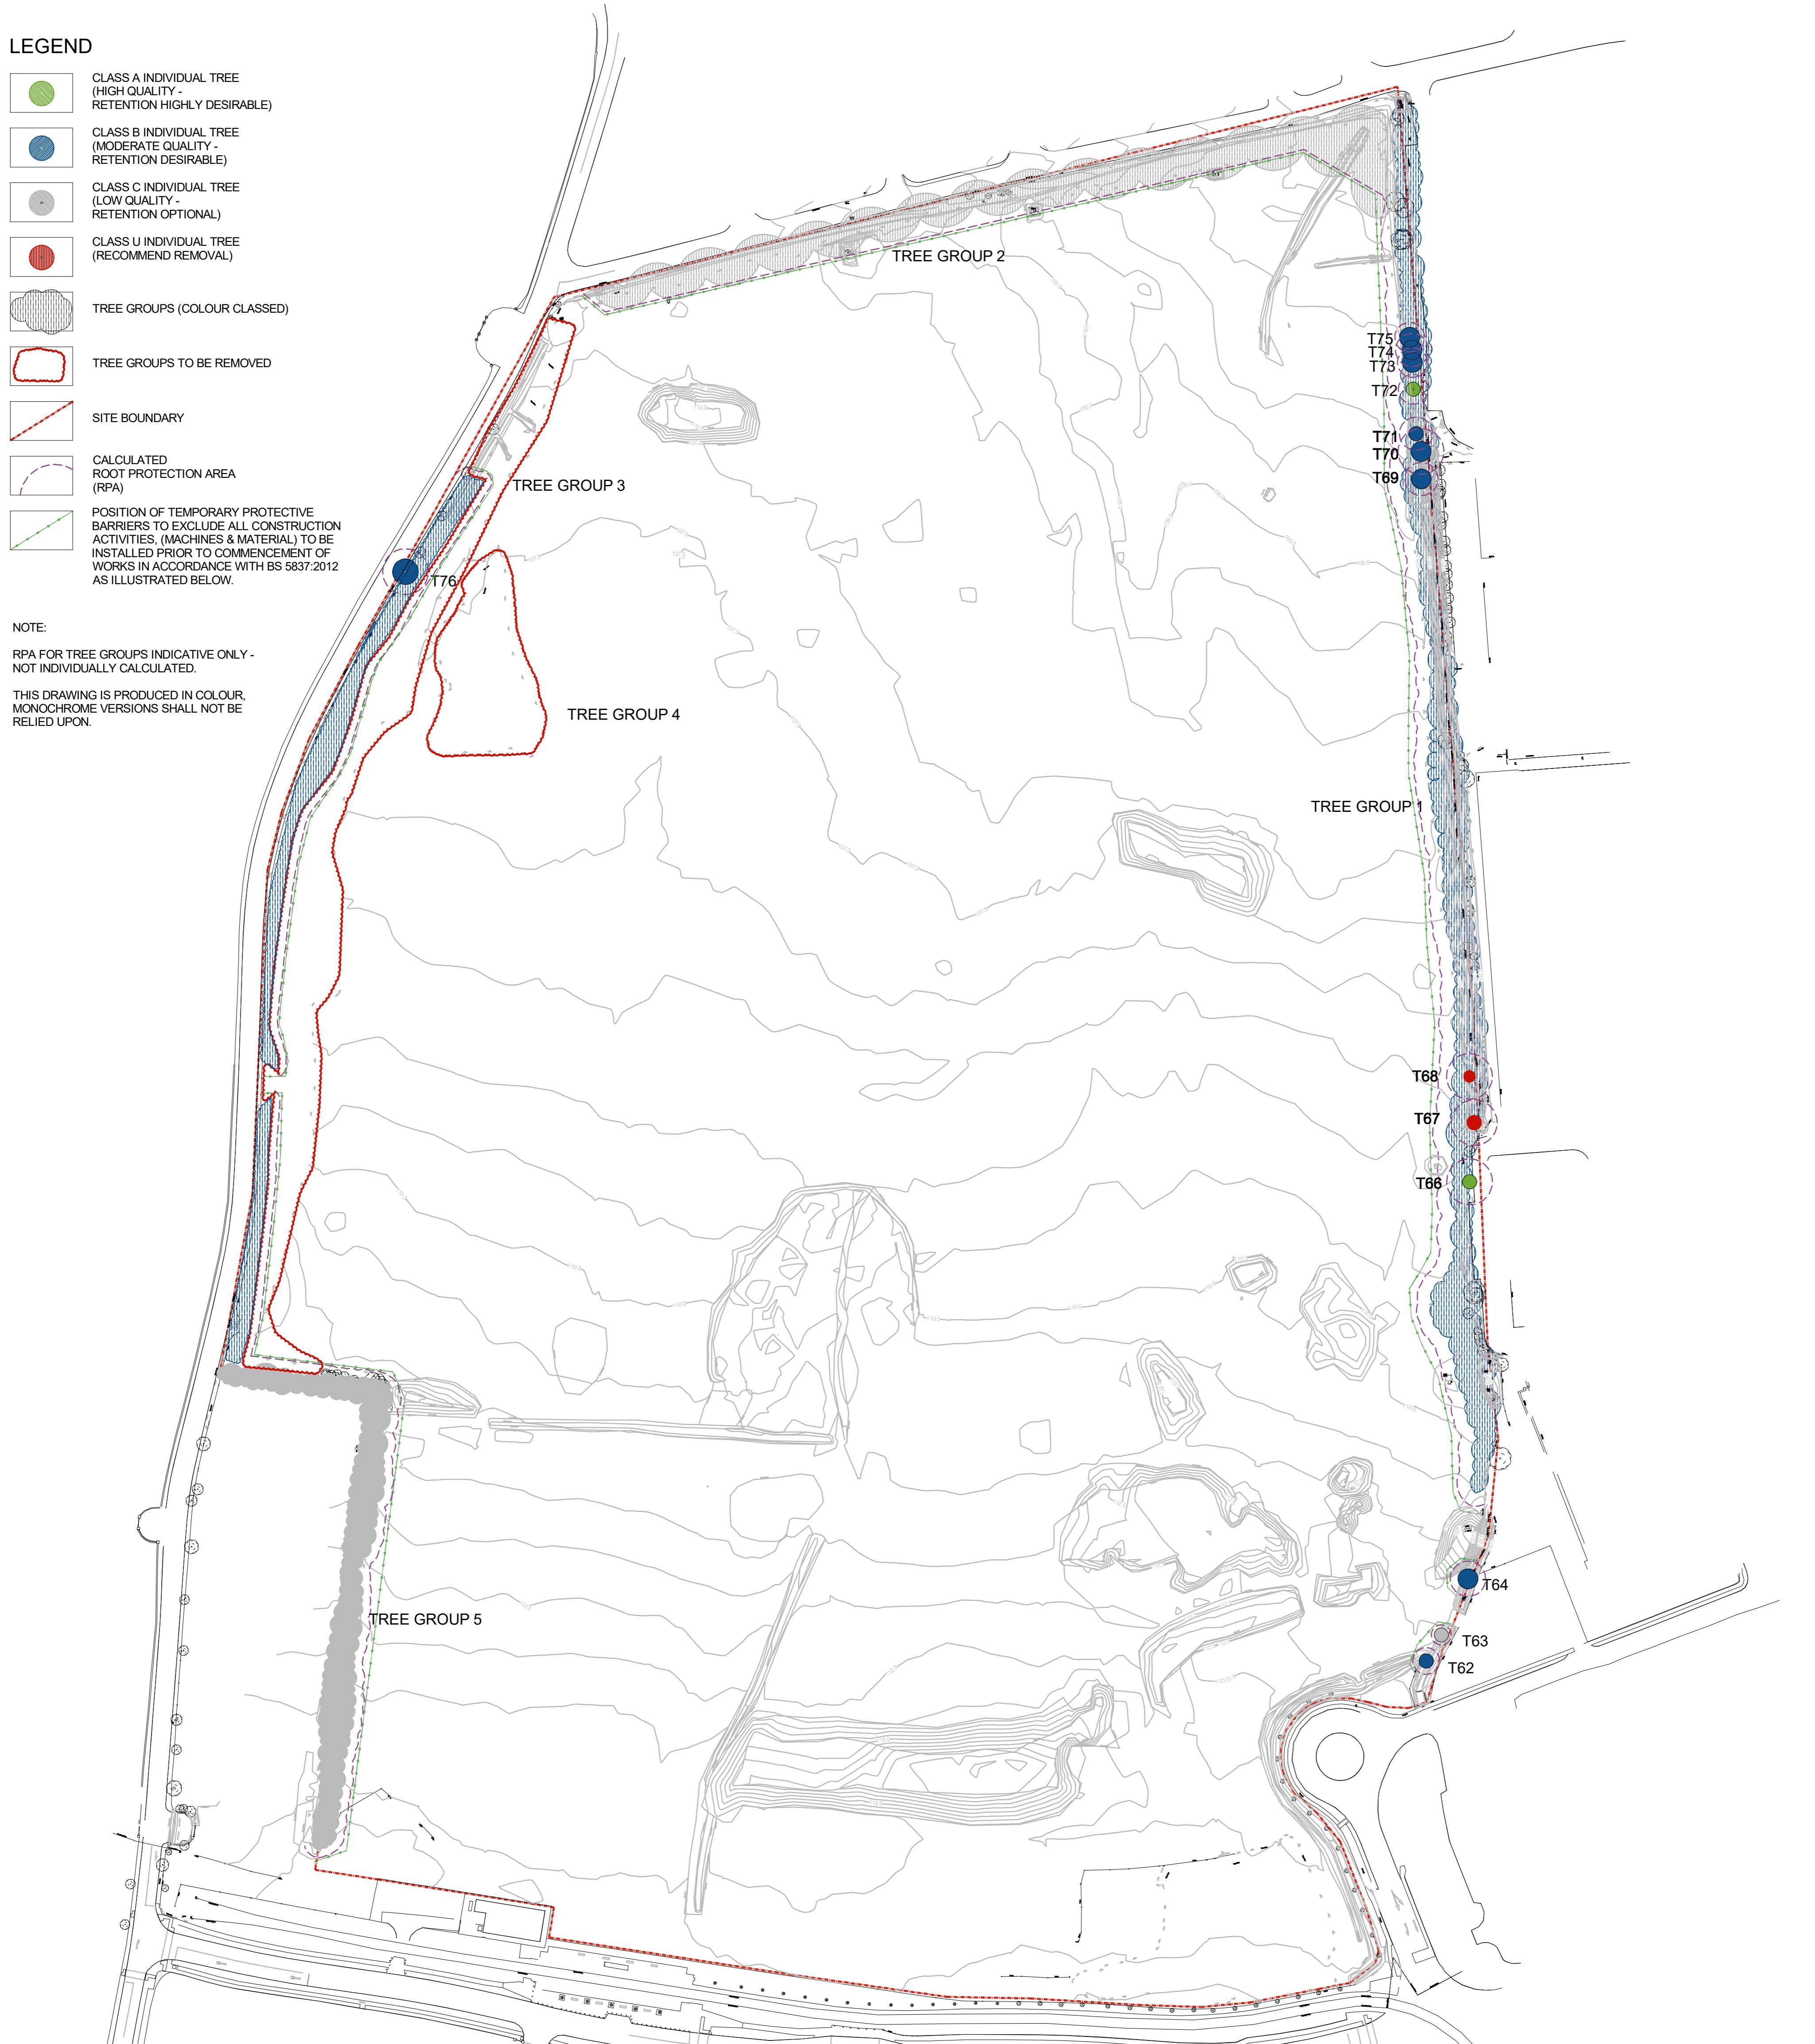
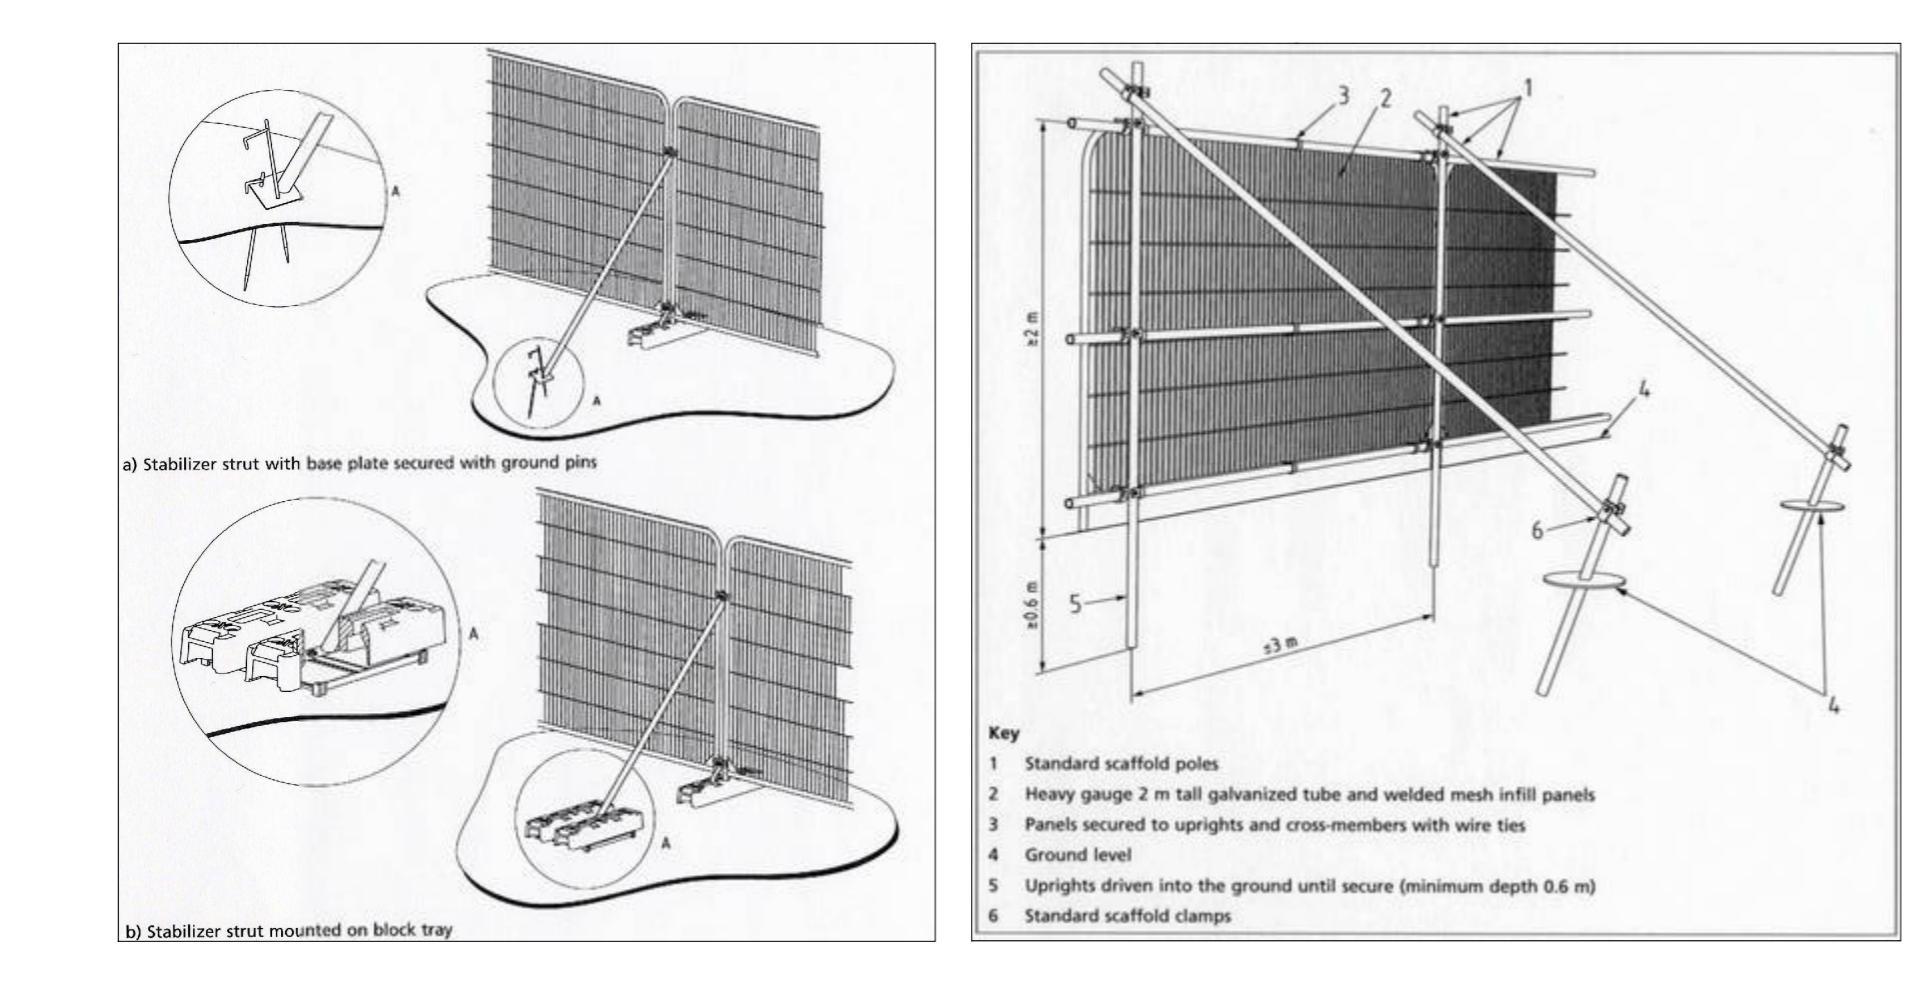
PROJECT:	DATE:	MARCH 2017
COOLDOWNS COMMON, CITY WEST MASTERPLAN	SCALE:	1:1250 @ A1
DRAWING:	DRAWN: CHECKED:	INIT KM
TREE PROTECTION & REMOVAL	DRAWING NO:	15422-T-103

3.7 It is anticipated that traditional tree protection measures such as tree protection fencing will be required to ensure the root protection zones of those trees being retained are not compromised during construction period.

As specified on Tree Removal & Protection Dwg No No15422_T_103
